Technical Bulletin 09-010

Cracking Due to Improper Control Jointing

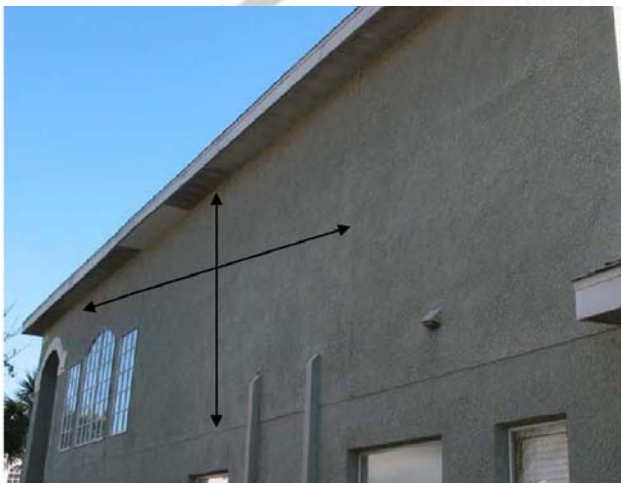
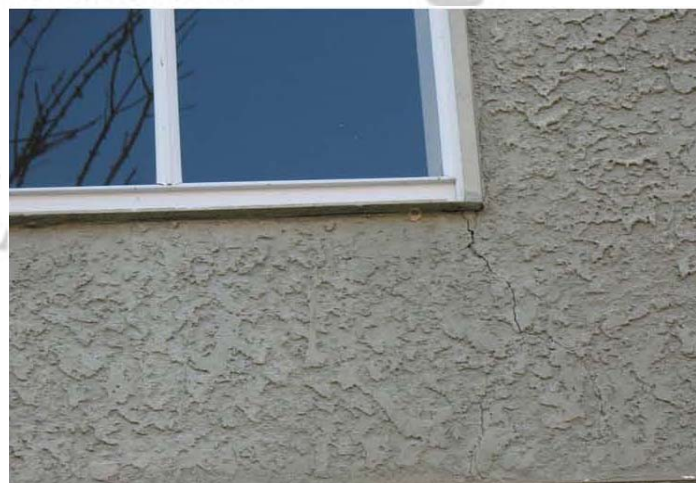
The cracking in your exterior cement-based plaster (stucco) over the frame sections of your home may be caused by improper control jointing.

See pictures below for an example of stucco cracking due to improper control jointing.

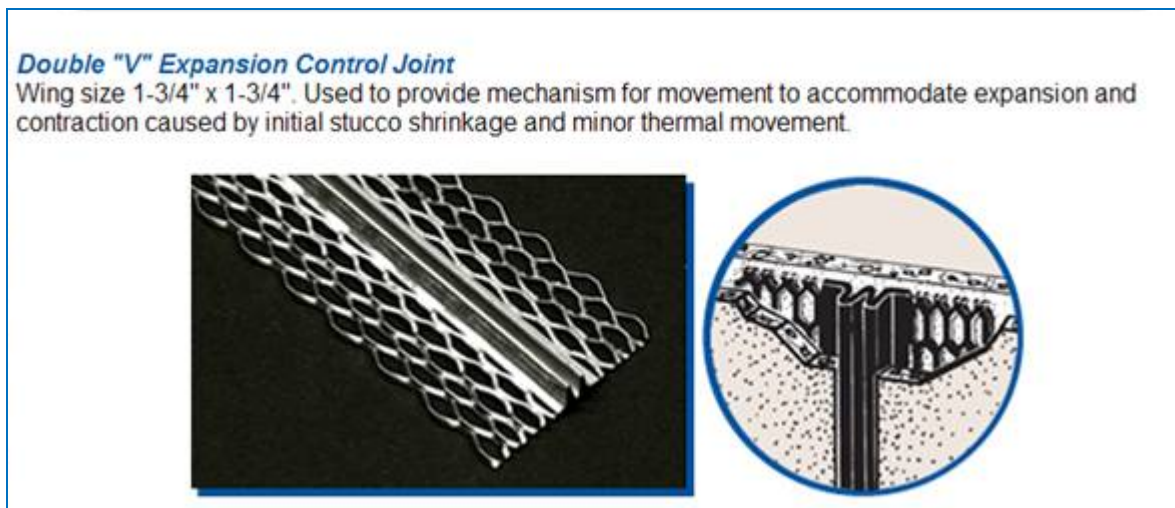
Figure 1 – Expansion Control Joint²

Figure 1 represents an example of an expansion control joint.
